MEMO

FROM: Shawn Middleton, PE
Spicer Group Inc.

DATE: September 22, 2015

RE: Riverwalk – Undercutting of Sidewalk at Riverside Motel

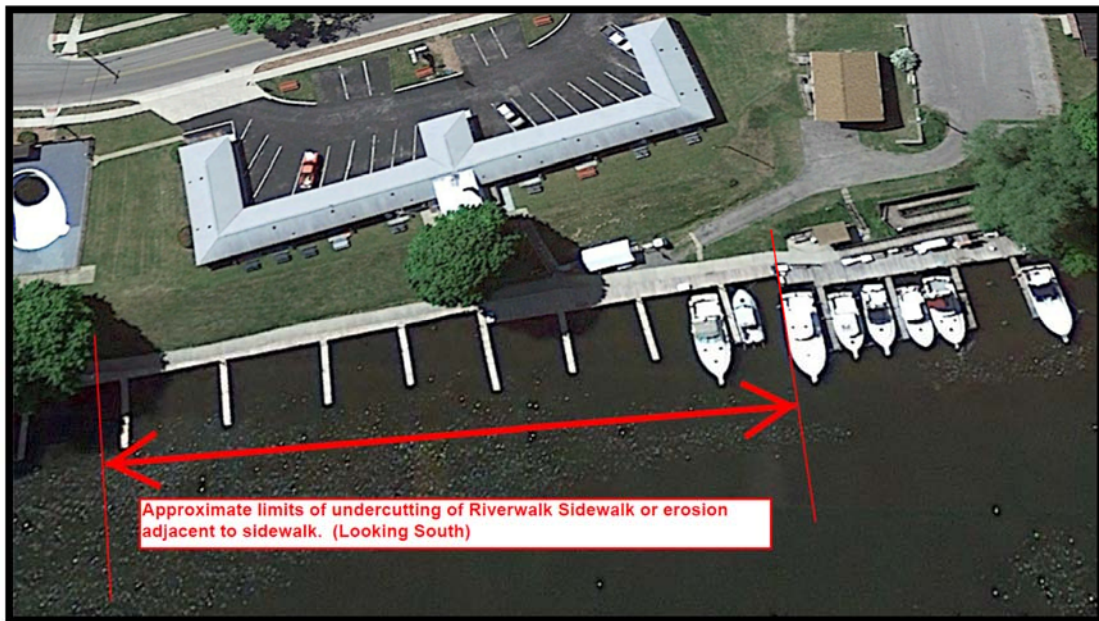
We were requested to inspect a segment of the City’s Riverwalk path. The specific segment we were requested to inspect was a section of six foot wide concrete sidewalk located directly north of the Riverside Motel. The City was notified that the concrete sidewalk in this section was significantly undercut (soil supporting the sidewalk had partially washed away). This undercutting was occurring on the sidewalk side of the wooden seawall located immediately north of the sidewalk.

The visual inspection of the supporting soil and underside of the concrete sidewalk revealed the sidewalk was generally undercut from 0 to 3 feet beneath the concrete sidewalk. The soil supporting the sidewalk generally had a vertical face of 2 to 3 feet caused by continuous wave action. This condition existed as far as could be seen to the east or west of our inspection locations.
