MEMO

DATE: September 22, 2015

RE: Riverwalk – Undercutting of Sidewalk at Riverside Motel

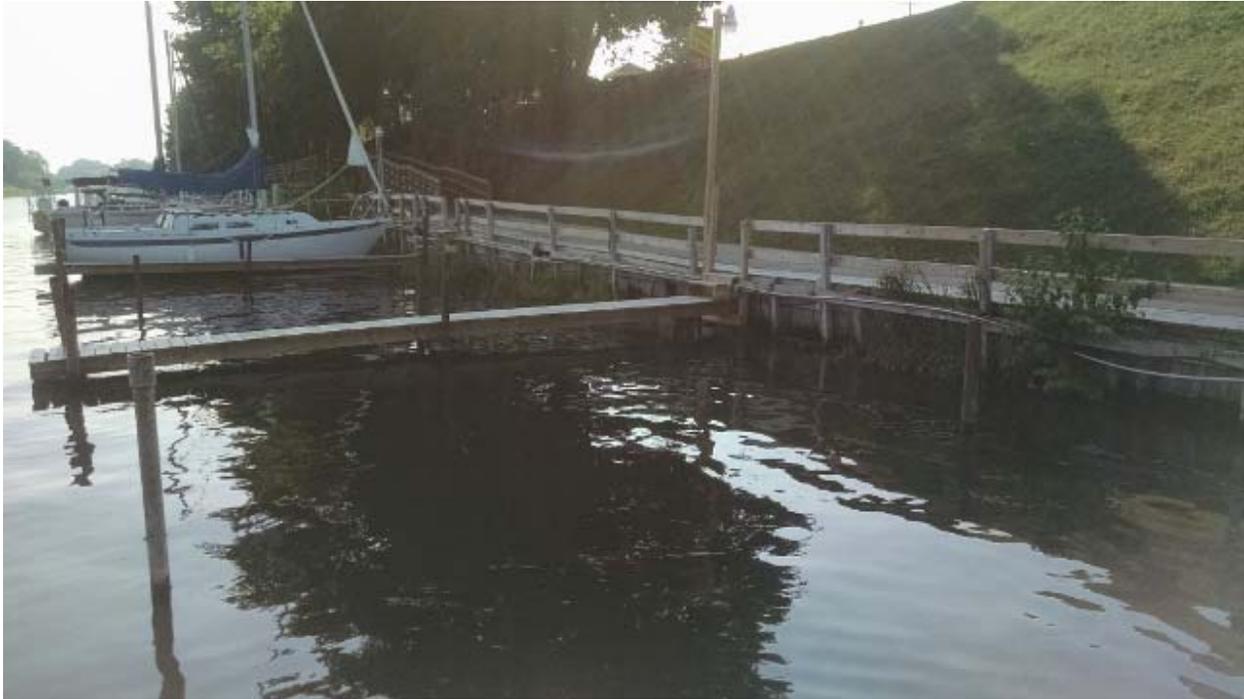
Name: 2015-08-14 10.11.05 (640x360)

In general, the wood seawall located along the northerly edge of the wood deck was in poor condition. The easterly 170 feet of the seawall was in the poorest condition with missing and broken planks, the westerly 130 feet of the seawall was in slightly better condition, but had significant areas where bowing of the wall has occurred and several openings allowing for erosion by wave action. Both sections of the seawall allow water to freely enter behind them causing erosion of the sidewalk's supporting soil.

Description: Looking SE at wood seawall. 150' west of east end of concrete walk. Wood seawall in poor condition, openings, broken timbers.

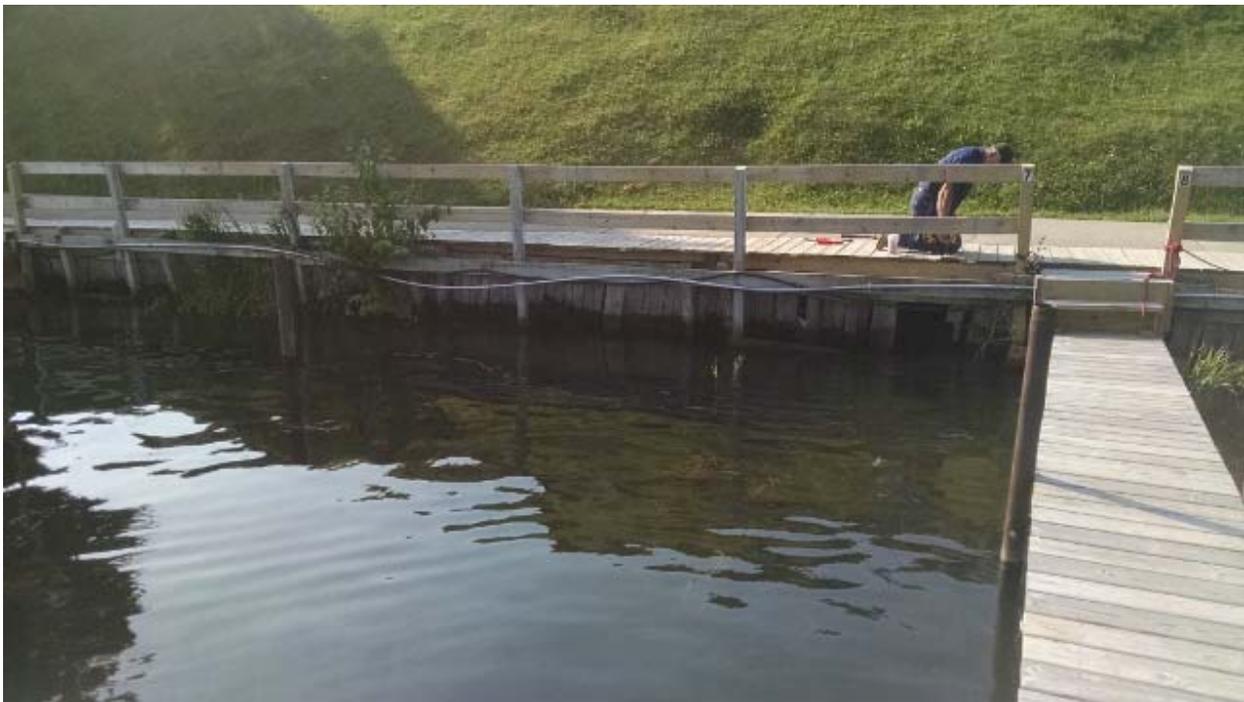
Name: 2015-08-14 10.11.09 (640x360)

Description: Looking South at wood seawall. 150' west of east end of concrete walk. Wood seawall in poor condition, openings, broken timbers.

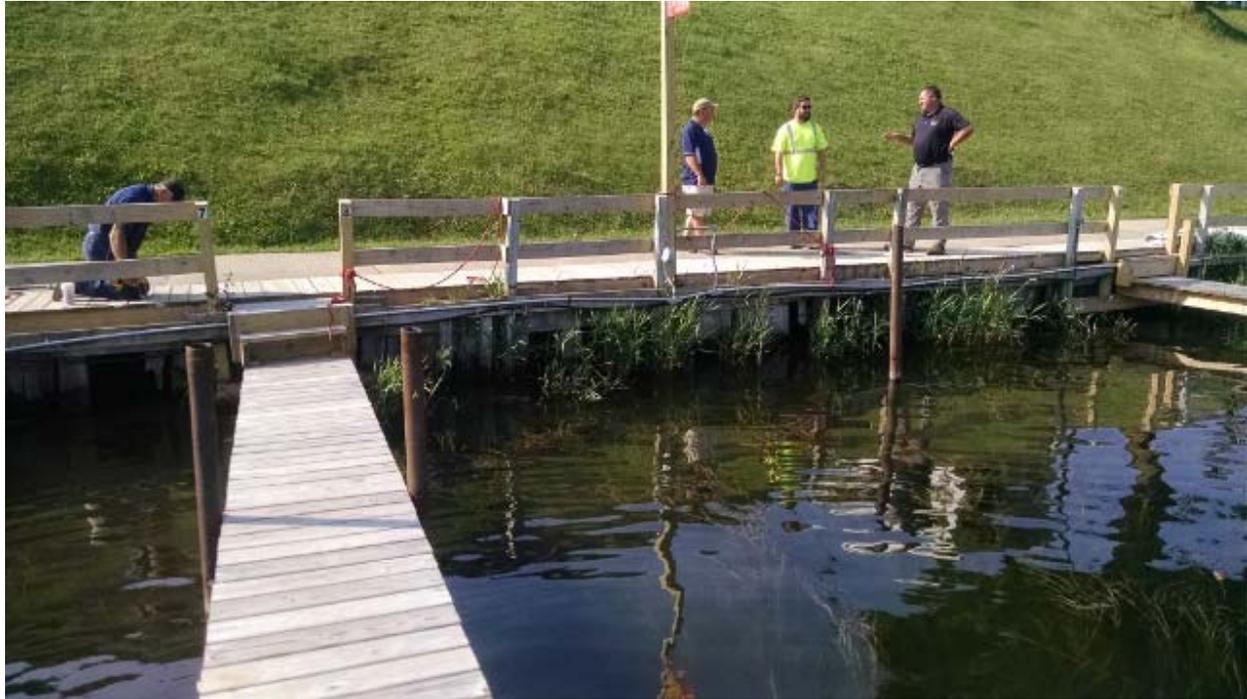
Name: 2015-08-14 10.11.12 (640x360)

Description: Looking SSW at wood seawall, 150' west of east end of concrete walk. Wood seawall in poor condition, openings, broken timbers.

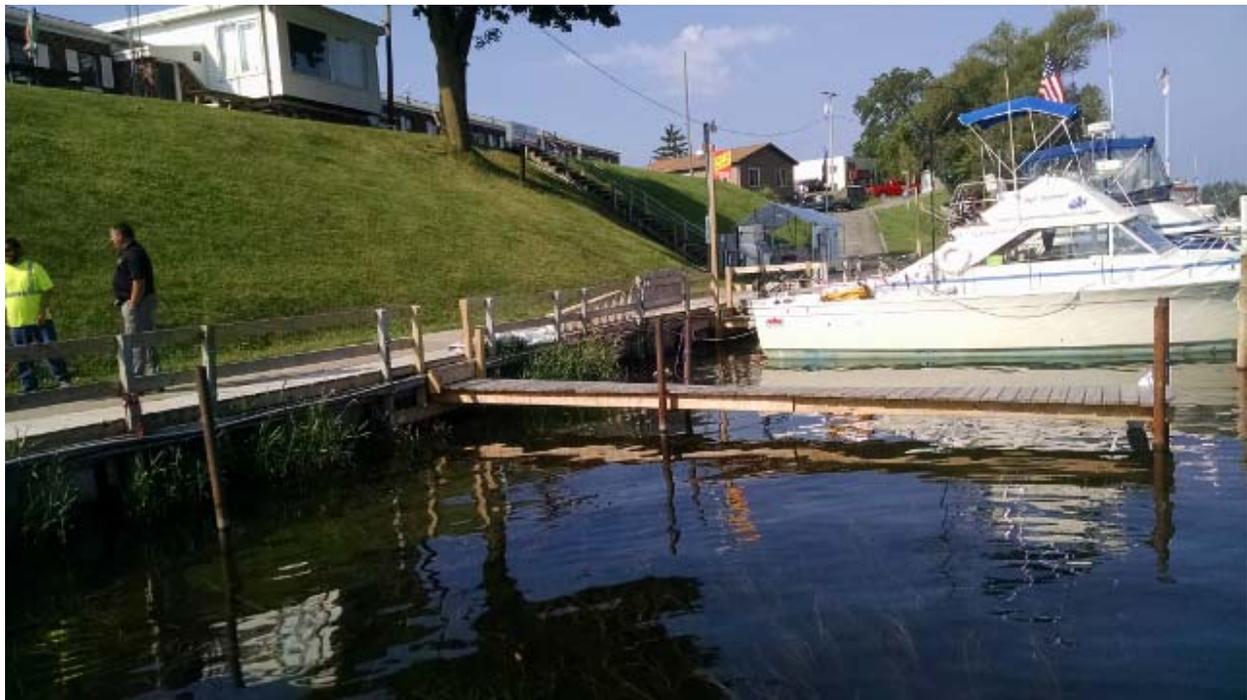
Name: 2015-08-14 10.11.15 (640x360)

Description: Looking SW at wood seawall, 150' west of east end of concrete walk. Wood seawall in poor condition, openings, broken timbers.

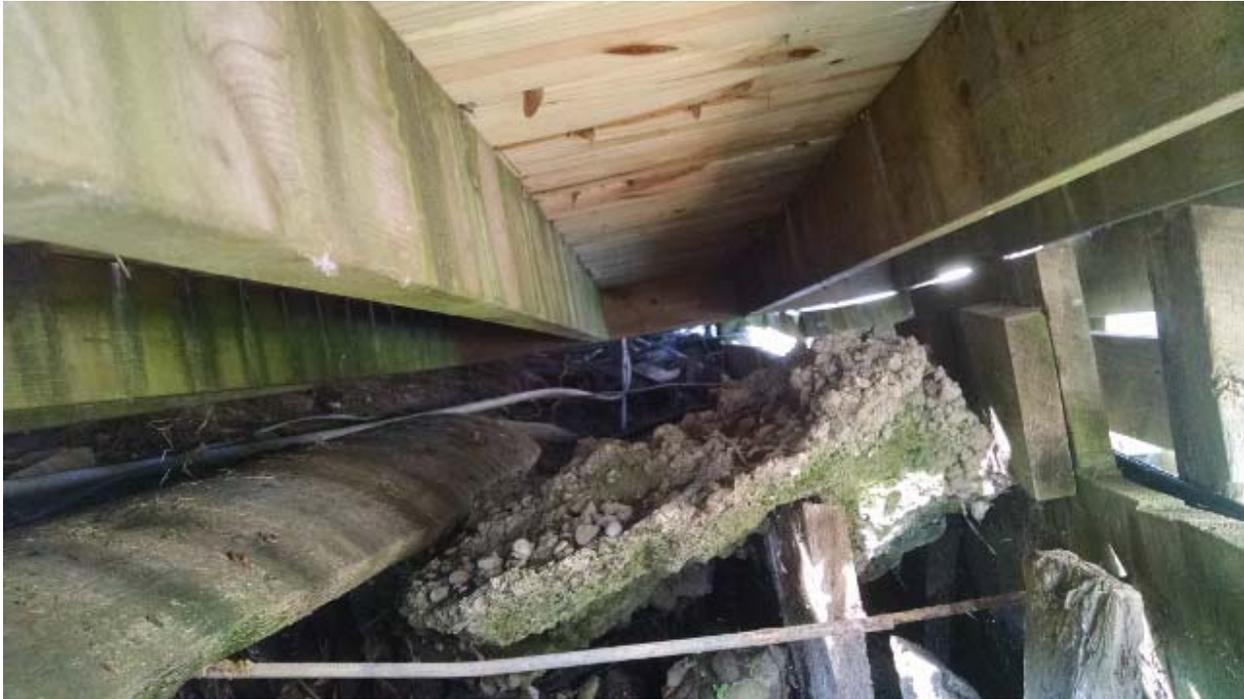
Name: 2015-08-14 10.13.26 (640x360)

Description: Looking west below narrow portion of wood decking. Erosion next to walkway on left side, conduit, exposed seawall tieback.

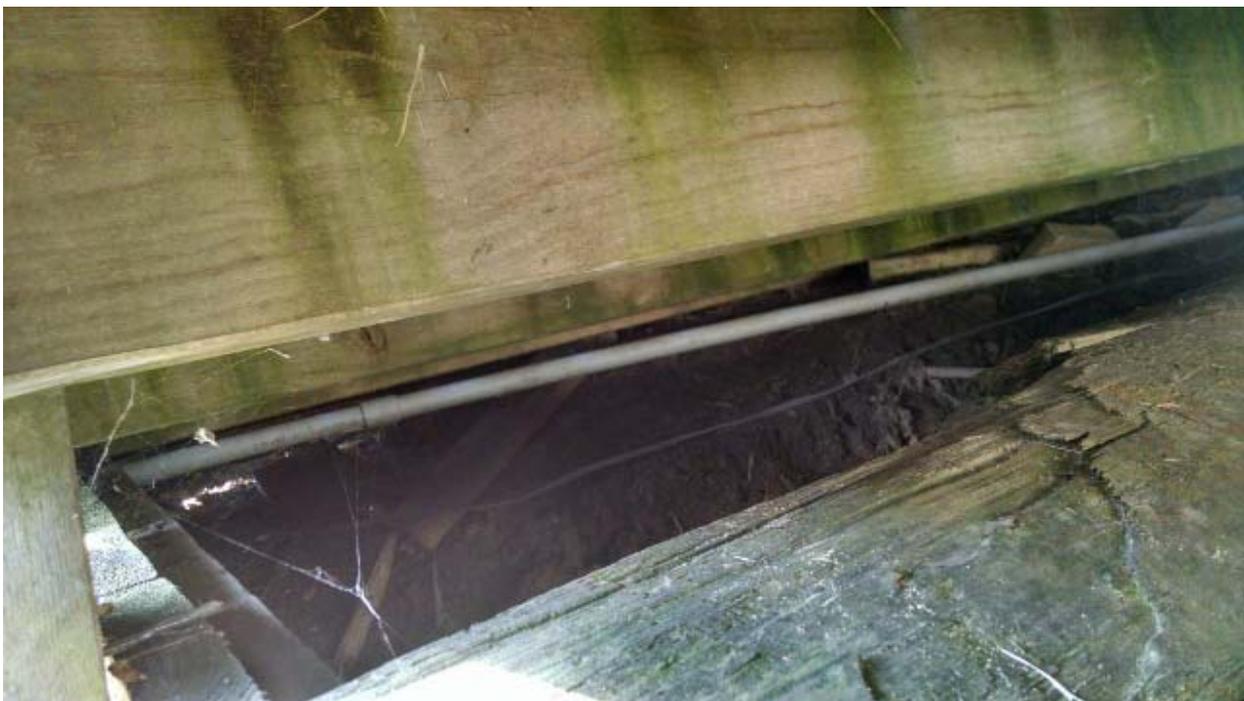
Name: 2015-08-14 10.13.31 (640x360)

Description: Looking SW below narrow portion of wood decking at erosion at sidewalk and conduit

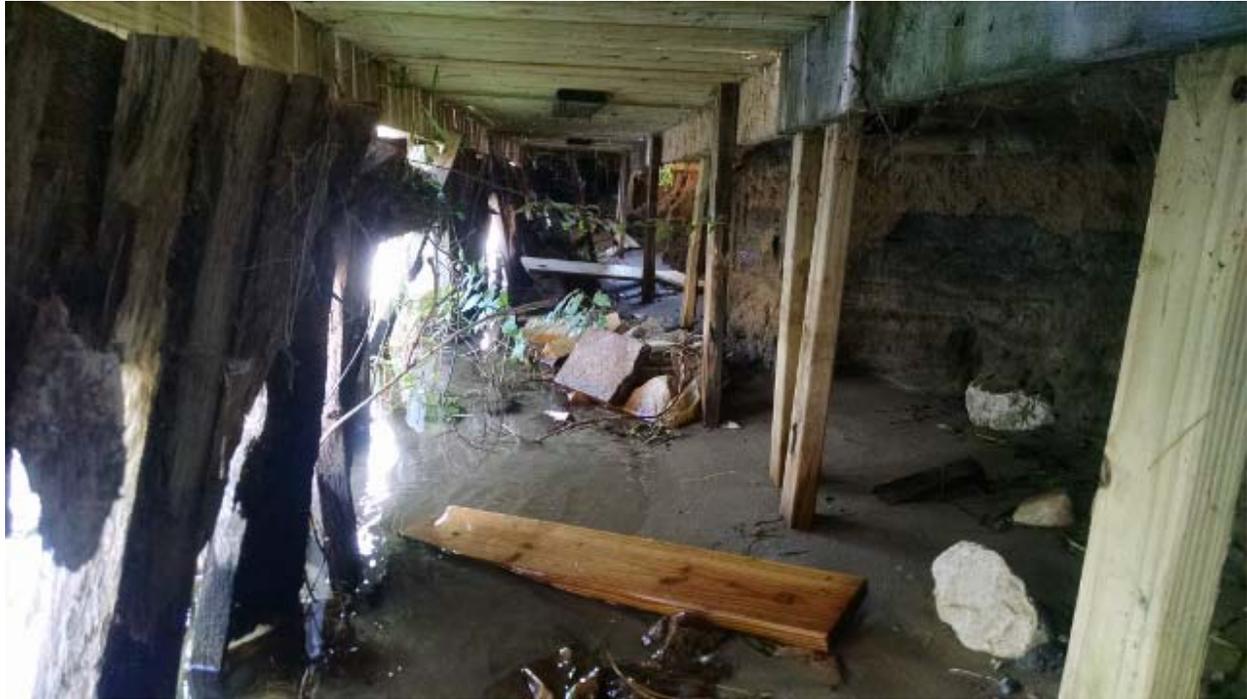
Name: 2015-08-14 10.15.31 (640x360)

The visual inspection of the supporting soil and underside of the concrete sidewalk revealed the sidewalk was generally undercut from 0 to 3 feet beneath the concrete sidewalk. The soil supporting the sidewalk generally had a vertical face of 2 to 3 feet caused by continuous wave action. This condition existed as far as could be seen to the east or west of our inspection locations.

The undercutting of the soil is primarily being driven by wave action behind the failing wooden seawall. As a wave enters behind the seawall the supporting soils are eroded by the wave action and then as the wave recedes the eroded soil is washed away. Runoff from the adjacent slope onto or below the concrete sidewalk may also be contributing to undercutting of the soil, though no specific areas of concentrated erosion were observed.

Description: Looking East below narrow portion of wood deck. Deteriorated wood seawall on left, undercutting of sidewalk on right

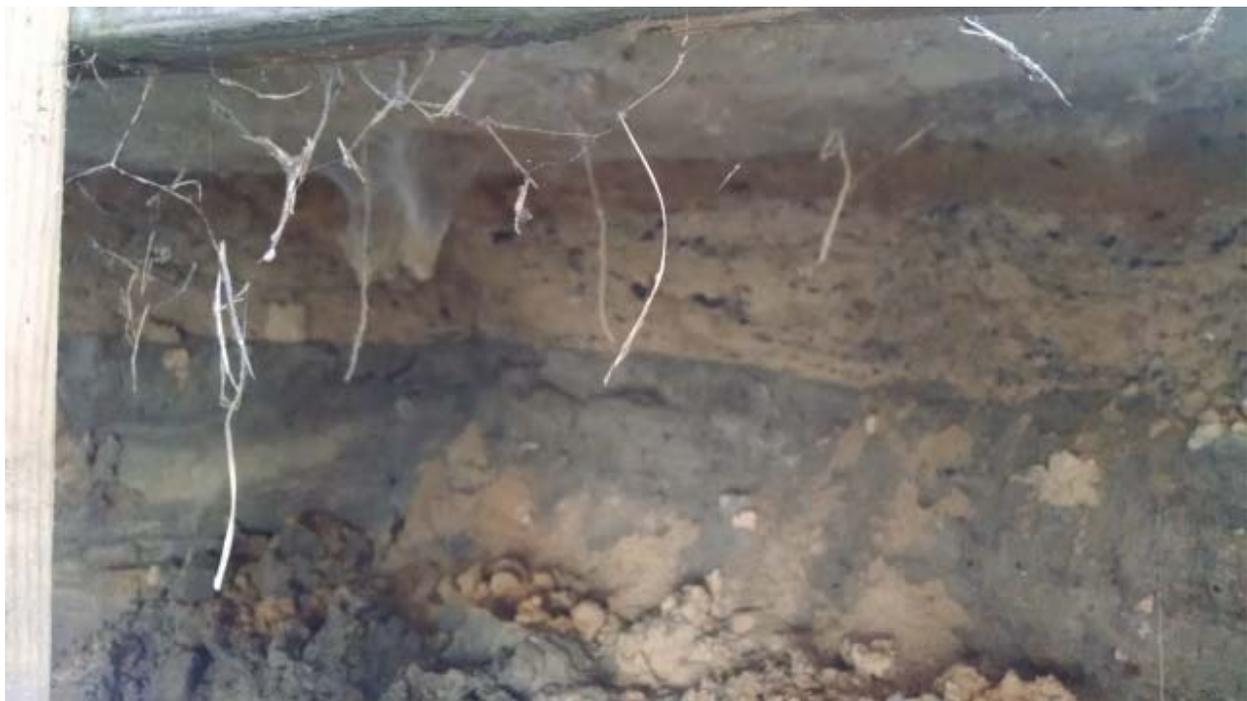
Name: 2015-08-14 10.15.36 (640x360)

Description: Looking south at face of eroded soil immediately below concrete sidewalk

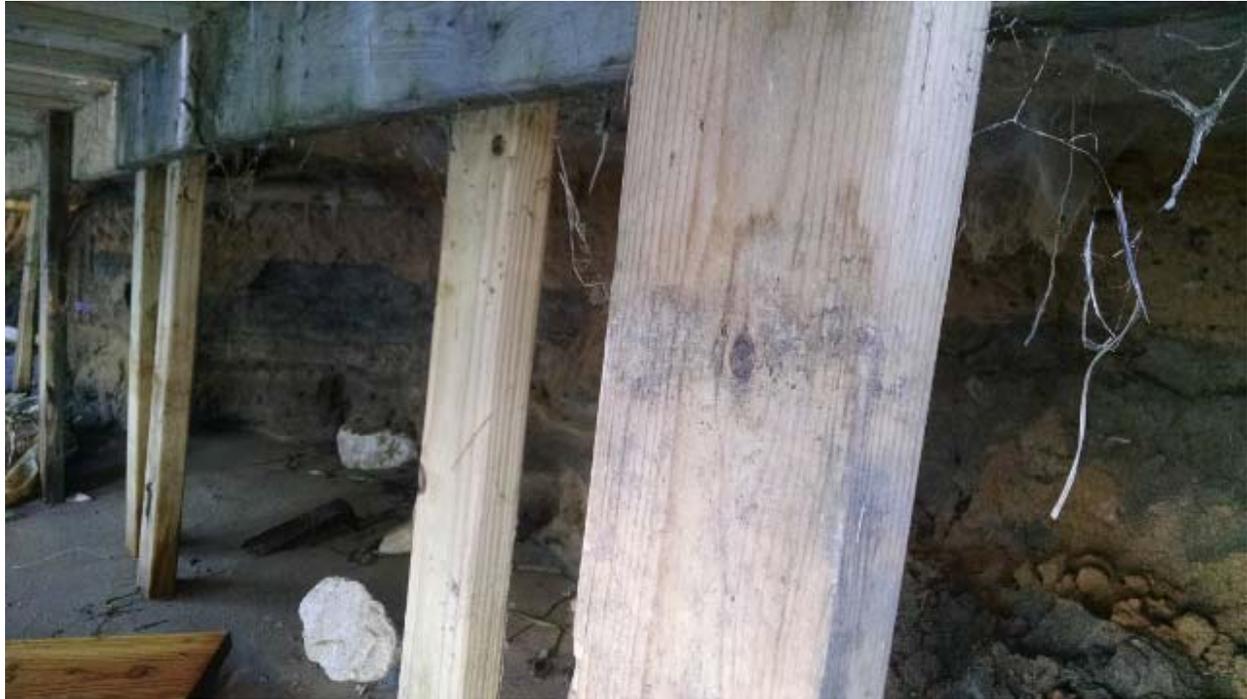
Name: 2015-08-14 10.15.40 (640x360)

Description: Looking SE at eroded soil face below narrow portion of wood decking. Concrete sidewalk south edge is approximately in line with joist in upper portion of photo.

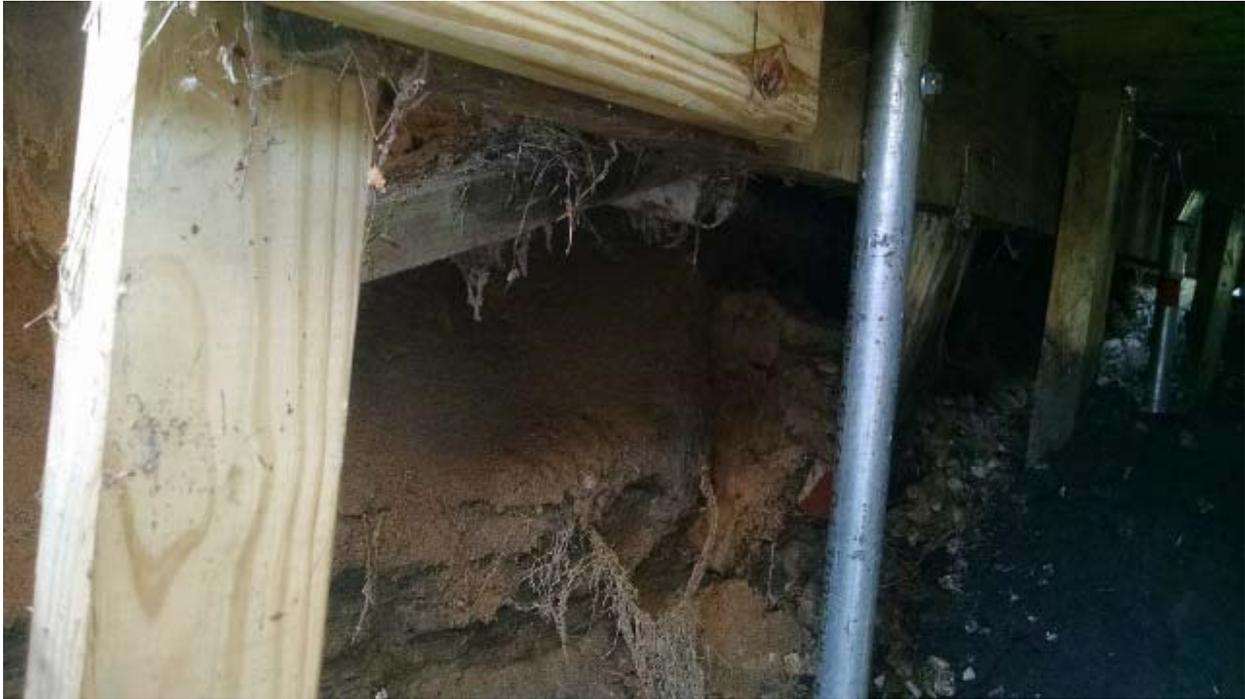
Name: 2015-08-14 10.15.53 (640x360)

Description: Looking SW at eroded soil face at approximate south edge of concrete sidewalk.

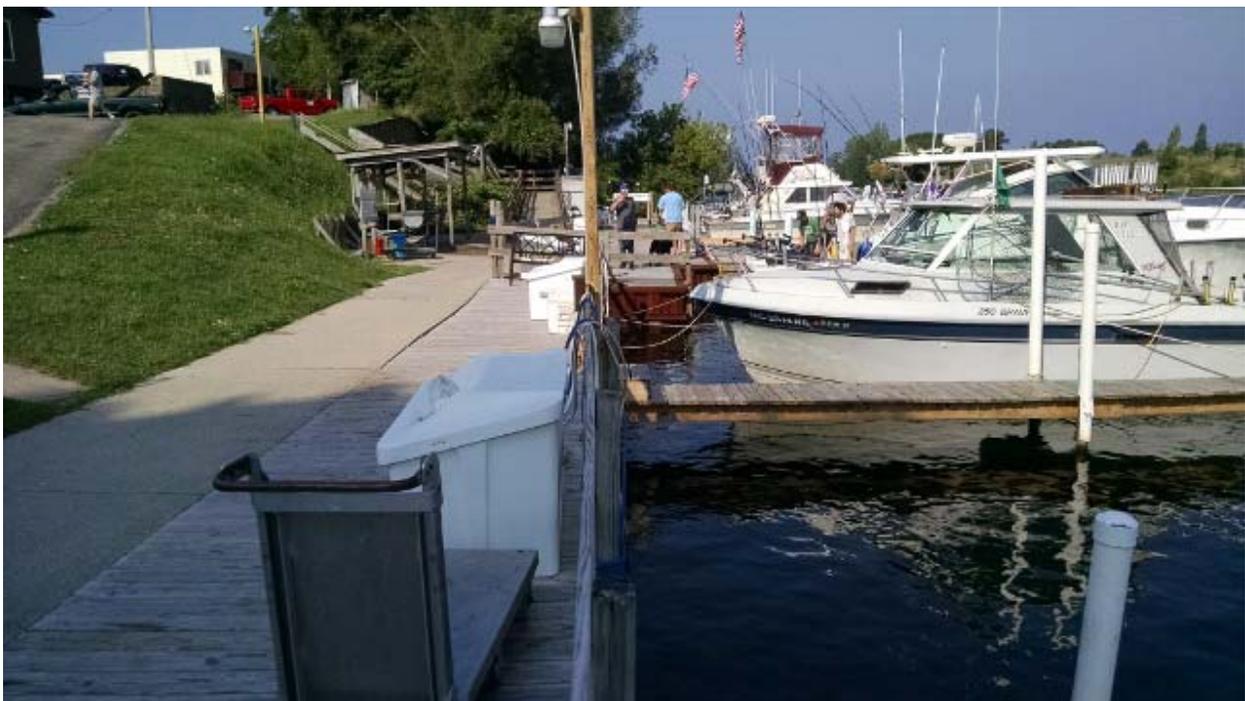
Name: 2015-08-14 10.32.27 (640x360)

Description: Looking West along face of seawall near transition of wood deck width.

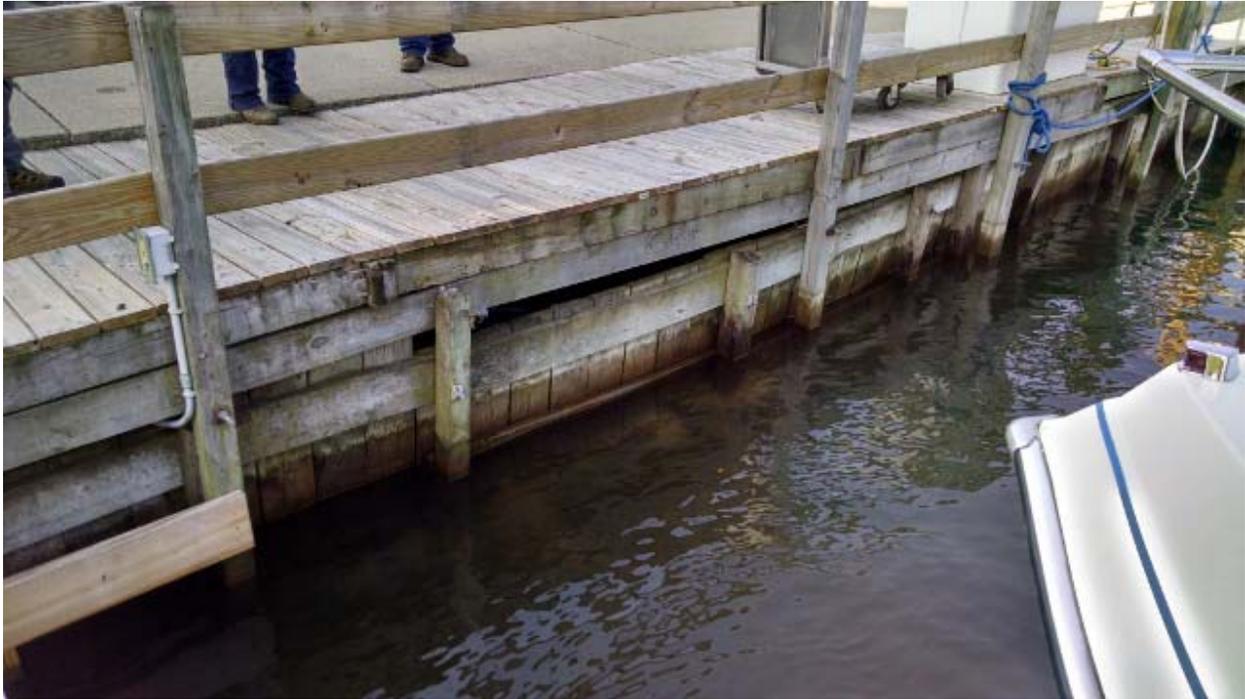
Name: 2015-08-14 10.32.41 (640x360)

Description: Looking SW at face of seawall at widened portion of deck. Some bowing of timber members and movement of water behind seawall.

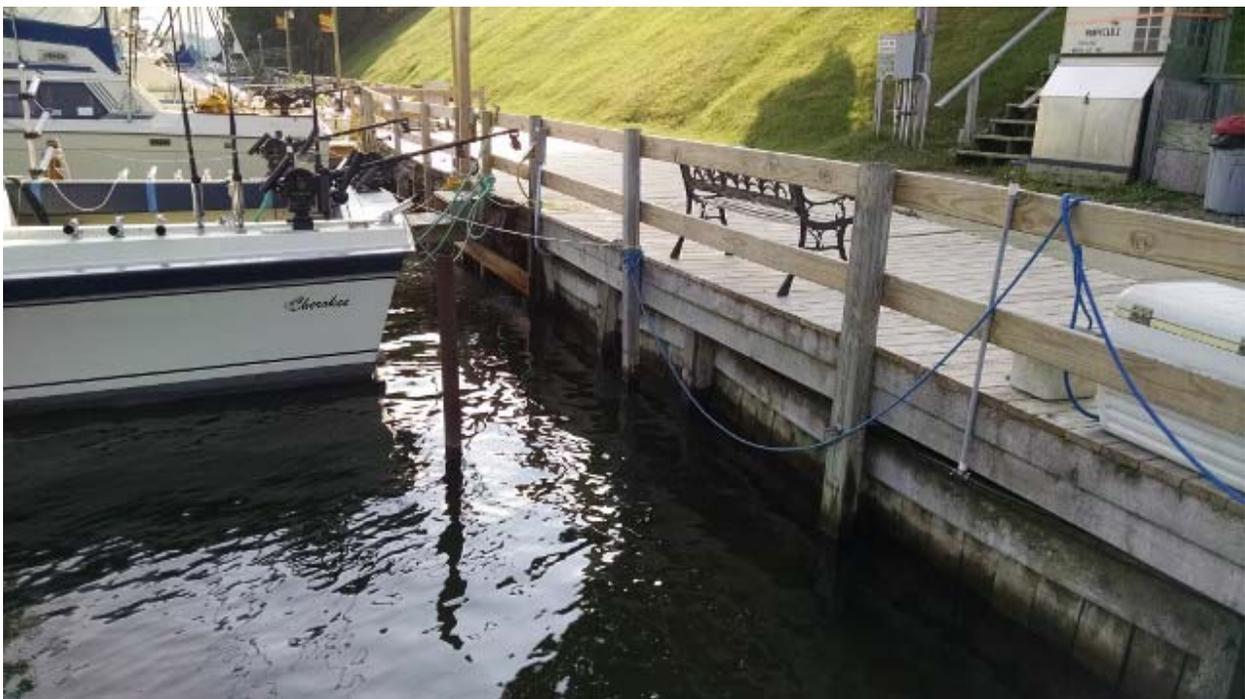
Name: 2015-08-14 10.32.44 (640x360)

Description: Looking SE at face of seawall at west end of widened wood decking. Bowing of wood timbers.
