MEMO

DATE: September 22, 2015

RE: Riverwalk – Undercutting of Sidewalk at Riverside Motel

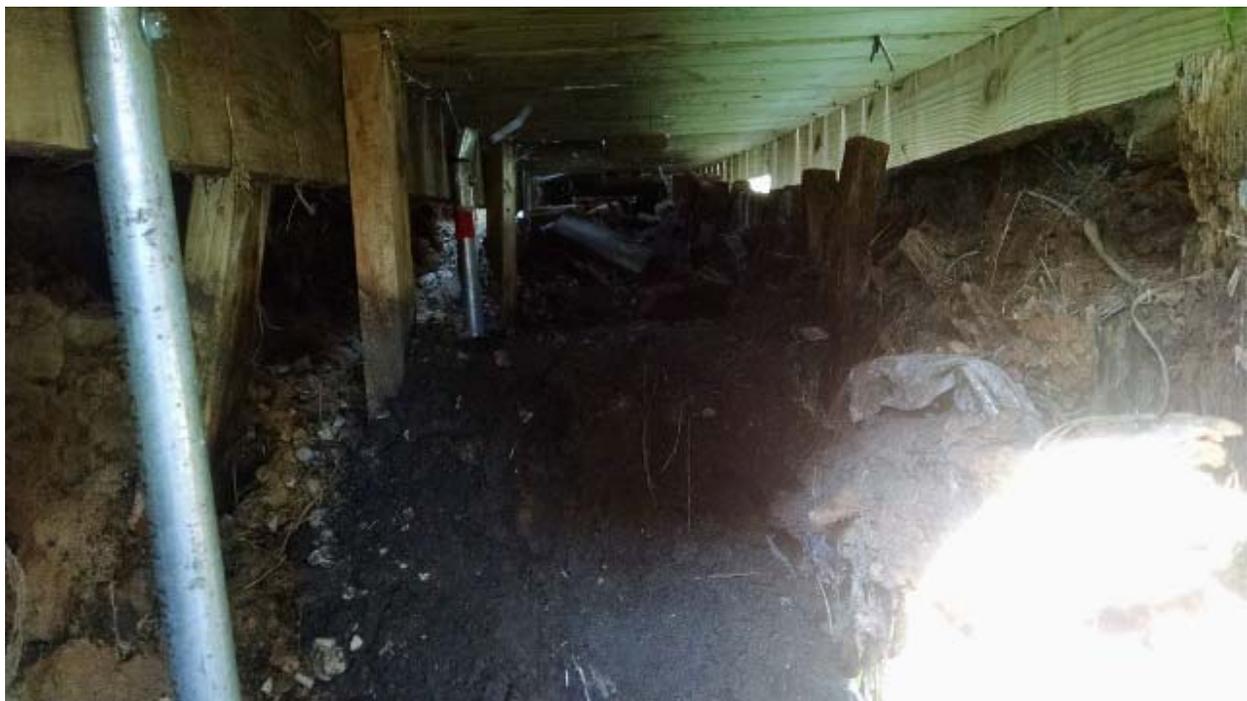
Name: 2015-08-14 10.15.40 (640x360)

Description: Looking SE at eroded soil face below narrow portion of wood decking. Concrete sidewalk south edge is approximately in line with joist in upper portion of photo.
